LEVEL 2

Your survey and valuation report

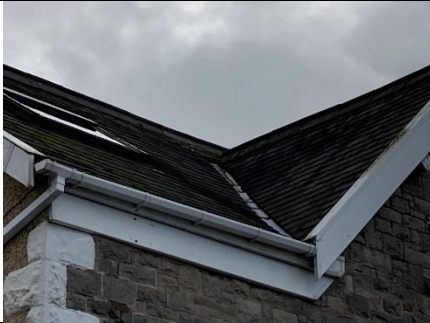
D2 Roof coverings

The roof is pitched, with a large dormer feature at the front, and covered in natural slate, which appears to be of local type. The roof has been re-covered in the past from what could be seen internally (not recently). So far as could be seen from ground level, some repairs have been necessary, with re-fixed slates just apparent in places, although not unusual for a roof of this type and age.

The substantial front dormer has a lead lined valley either side where it adjoins the main front roof. Leadwork appears to have been patched, certainly where could be seen to the left hand side. Accessibility around the front of the building prevented a clear view of the opposing, right hand valley. This should be inspected closer to when chimney maintenance is carried out (rating 2). Leadwork can wear thin with age and leaks can develop. These areas are likely to require future attention. Some loose/slipped slates were just apparent where could be seen adjoining the valley. There appeared to be some loose slates just above the top of the valley, where this area should be checked by a roofer and a repair may be needed (rating 2).

There are modern style Velux windows (two at the rear and one at the front), which will have been installed relatively recently, and details should be confirmed. An old skylight remains at the rear, which is deteriorating and should be replaced (rating 2). You may wish to obtain advice and estimate before purchase.

There appears to be a slight sag to the outer rear verge, which may indicate deterioration in supporting timbers, although now clad with PVC, and plastic edging fitted (this helps keep outer tiles secure in high winds). This should be monitored, and future attention may well be needed. Opposing side verge may also be slightly uneven. Difficult to see clearly from ground level due to the height of the building and inaccessibility.

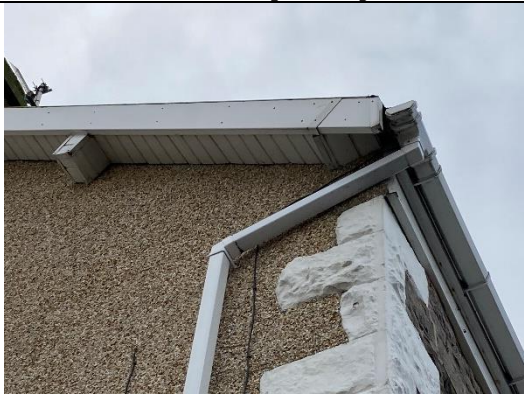
D8 Other joinery and finishes

The eaves and front gutter boarding, including dormer fascia all appear PVC clad so far as could be seen from ground level. There is no projecting/exposed eaves woodwork at the rear. PVC is low maintenance. Installer details and age should be confirmed.

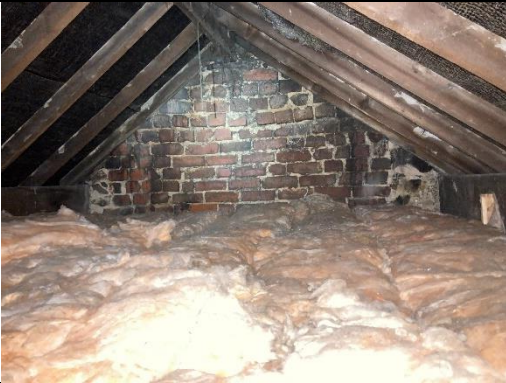
E1 Roof structure

The second floor is part in the roof area, with outer sloping ceilings beneath the roofline. There is a hatch in the top floor landing ceiling, which enables a view into the upper part of the roof space. This revealed the roof of traditional construction. Slates have been laid over conventional roofing felt, which indicates that whilst it has been re-roofed, it will have been some time ago.

Brickwork seen to the upper gables either side will no doubt be the flue areas. Limited view of rubble stone to one of the gables was evident.

The upper ceilings are insulated in fibreglass quilt, generally less than present day recommended standards. Outer/sloping ceilings may have been insulated when re-roofed, but unfortunately not possible to determine, and certainly will be less than present day recommended standards. Checking and upgrading insulation to these sloping areas will be difficult without disruption to the plaster lined surfaces. The upper roof space ideally should be insulated to modern standards, but the roof space will need to be ventilated, as well insulated roof spaces can suffer condensation problems in cold weather (rating 2).

Exposed main roof timbers below the second floor ceiling lines have been stained and varnished.

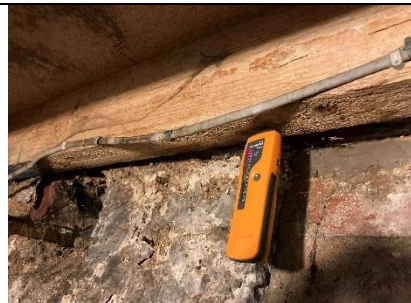
E4 Floors

Generally, floor surfaces were covered by well-fitting laminate, carpets etc, which prevented inspection of the top surface.

Although difficult to confirm, there appears to be a solid floor in the hall, and rear kitchen downstairs. Other ground floors are assumed suspended timber.

The timber floor is visible over the rear corner cellar, where it has been renewed in the past, modern woodwork evident, and the floor deck in chipboard. Joist ends have been wrapped in damp proof material in places where built into damp stonework. The cellar is however generally damp, which has affected timbers otherwise, and there is poor ventilation. The left hand side floor joist abutting damp stonework is also affected by the dampness. Decayed woodwork around the front cellar area appears to be the original, and it was just possible to see into the gap beneath the front living room floor, where original joists and boards were apparent. There was woodworm evident in joist ends, and the wall plate.

Apart from a single air vent into the cellar, there is no sub floor ventilation. Timber ground floors must be adequately ventilated beneath, particularly in older buildings where there is dampness, otherwise rot can establish. It is therefore necessary prior to purchase to arrange for floors to be investigated by a reputable timber preservation specialist contractor/joiner, who should open up and check front corner areas etc. This will require the lifting back of floor coverings in places (by arrangement with the vendor). Estimates for treatment and any repairs should be obtained, together with provision of adequate sub floor ventilation. Work should be carried out backed by a reliable guarantee (rating 3).

Ground floor timber floors were satisfactorily firm to tread, but nonetheless, investigation is strongly recommended.

Some irregularity was evident beneath the landing carpet. Boards visible in the attic room were typically affected by woodworm, which is largely likely to be old. This is also very typical in a house of this age. Should carpets etc be lifted for renewal in future, attention to woodworm and repairs to ageing / uneven floorboards may well be necessary (rating 2).

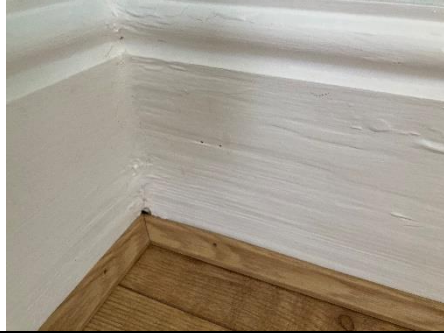
E7 Woodwork (for example, staircase joinery)

Woodwork (skirtings, doorframes etc) is largely assumed original, with feature moulded sections. Some parts, certainly in the living room, may have been replaced in the past, probably due to decay in the original. Woodwork in damp positions is prone to decay, and there is suspected rot in some of the woodwork in the front dining area (painted over), rippled surface evident. Dampness in the lower ground floor woodwork was also apparent. Joinery replacement and repairs likely to be needed during renovation, dependent upon outcome of further investigation recommended earlier (rating 2). Repairs to woodwork elsewhere may also be found necessary.

Original style features also include the dado, and picture rail in places.

Ground floor internal doors have been replaced in reproduction style, with doors to the upper floors mostly assumed the original, generally having a waxed/polished finish.
